**2022 DAM INSPECTION REPORT  
FOR  
HOUGHTON LAKE LEVEL CONTROL STRUCTURE**

*ROSCOMMON COUNTY*

December, 2022

MICHIGAN DEPARTMENT OF ENVIRONMENTAL QUALITY  
LAND AND WATER MANAGEMENT DIVISION  
**DAM INSPECTION REPORT**

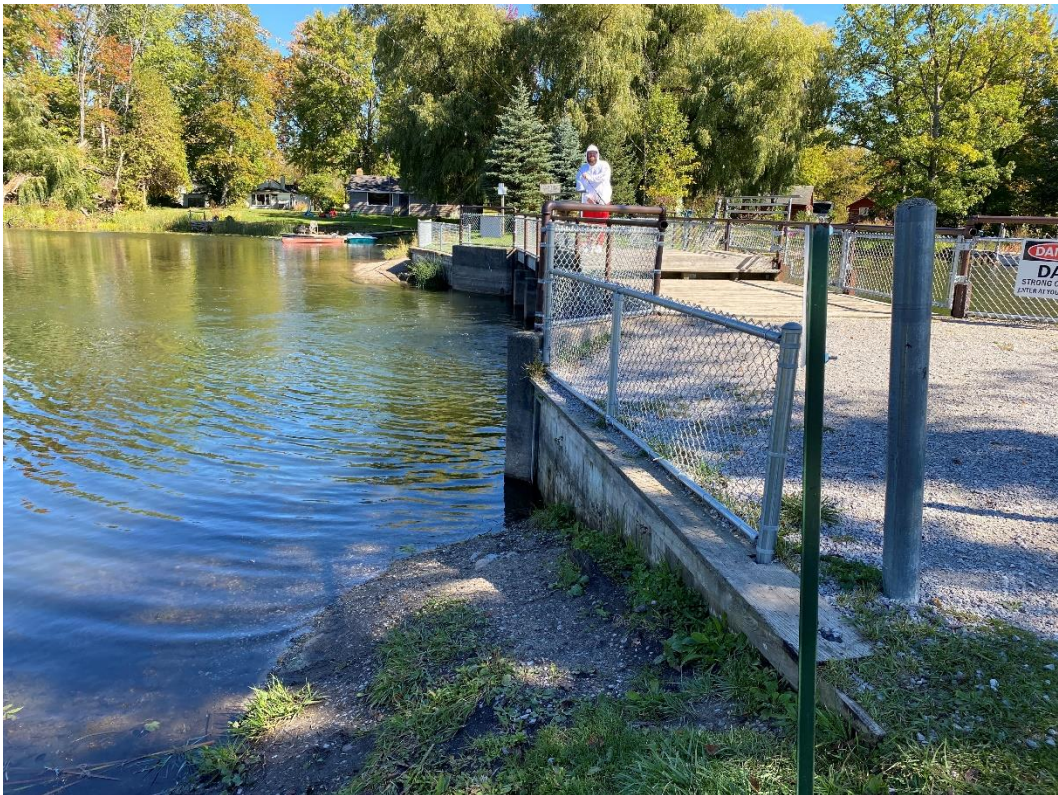
Downstream Side of Dam, From Left

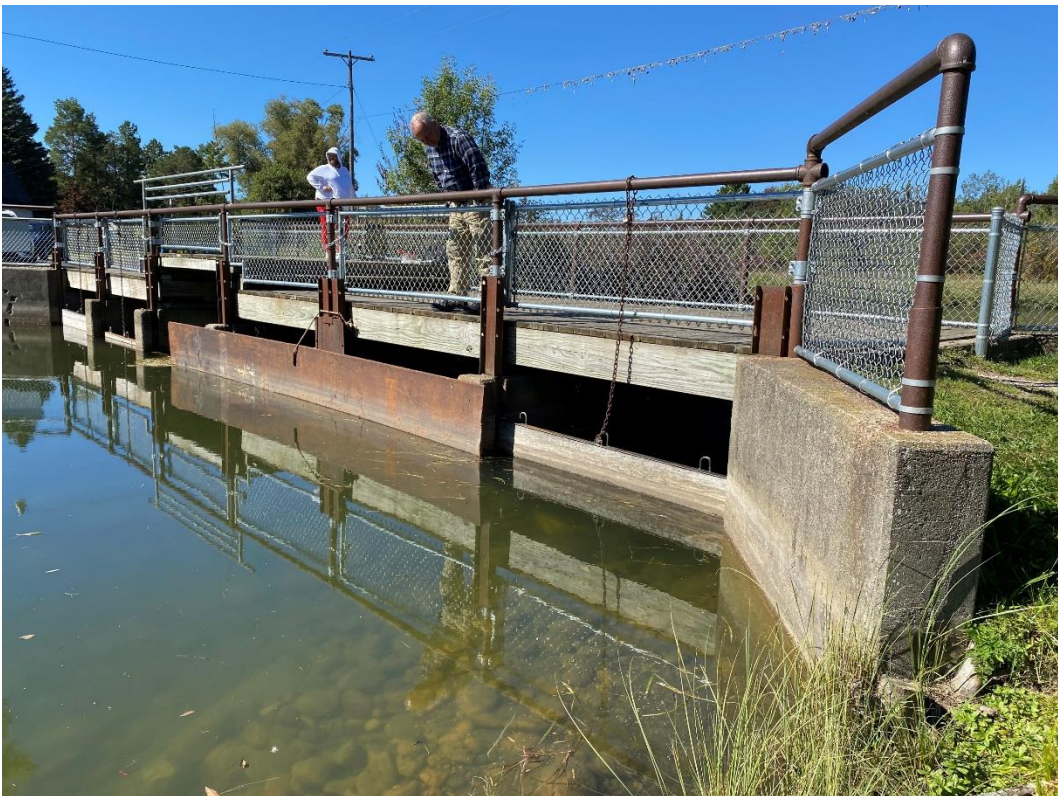
Upstream Side of Dam, From Right

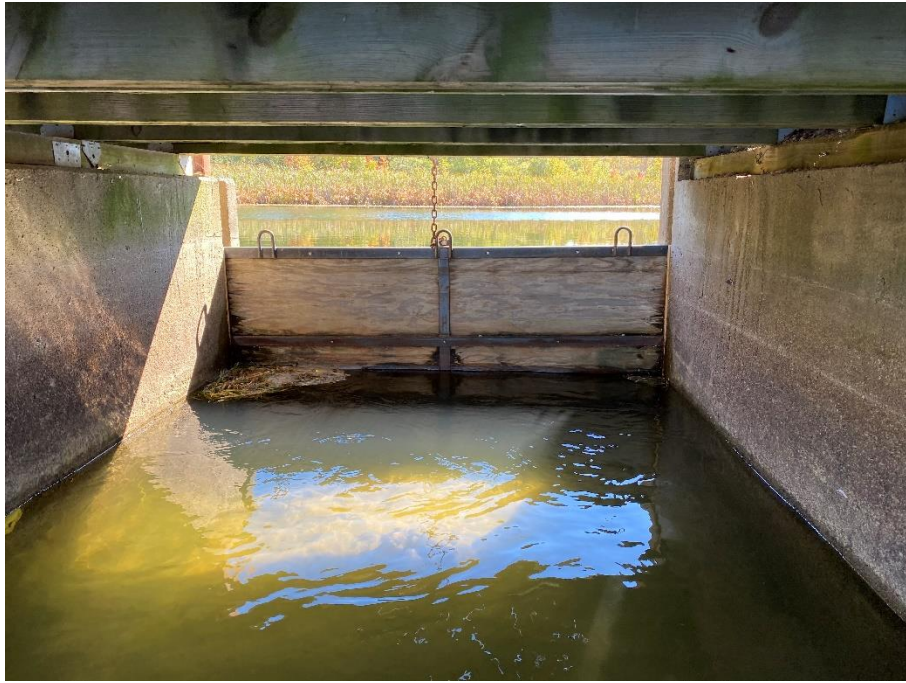
Far Left Spillway Bay

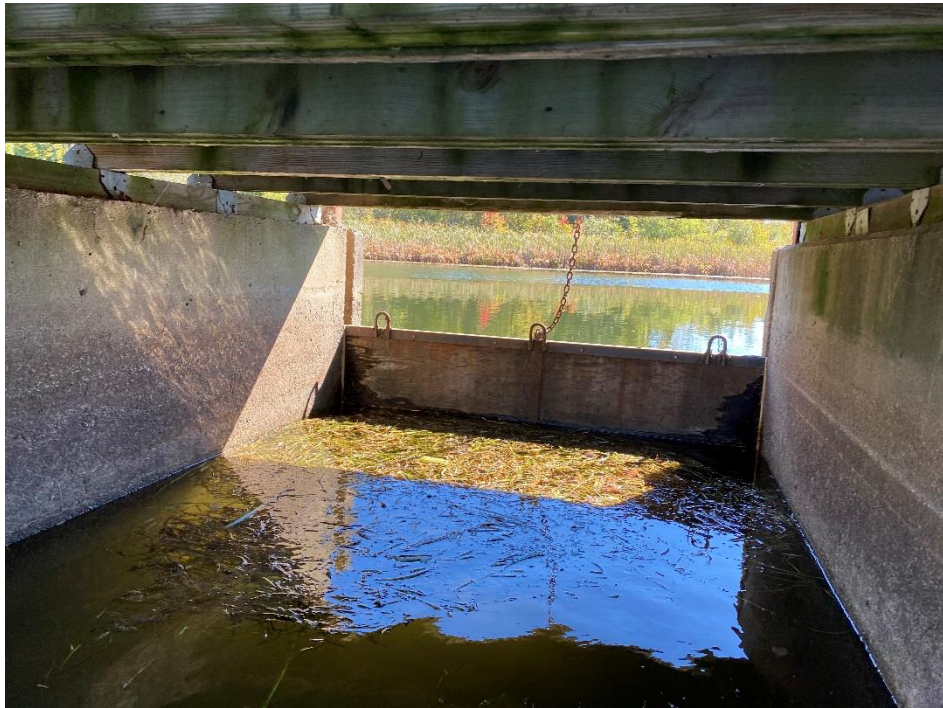
Spillway Bay, 2<sup>nd</sup> From Left

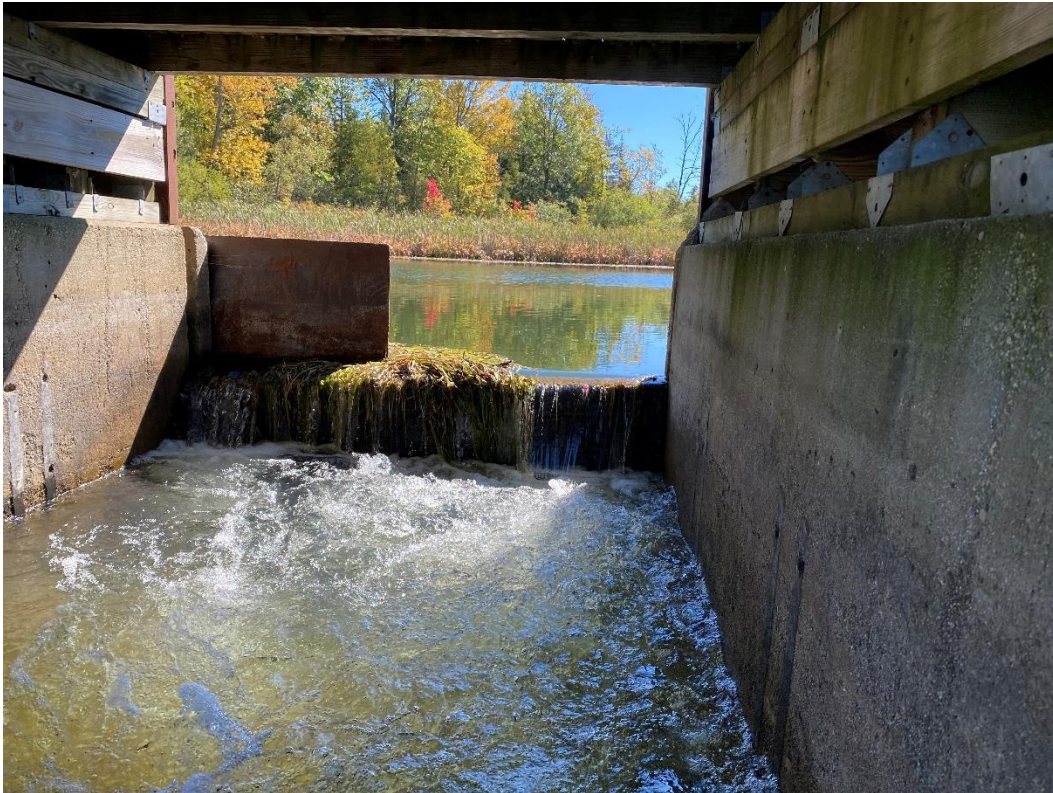
Spillway Bay, 3<sup>rd</sup> From Left. Note Steel Plate Used for Adjacent Bays

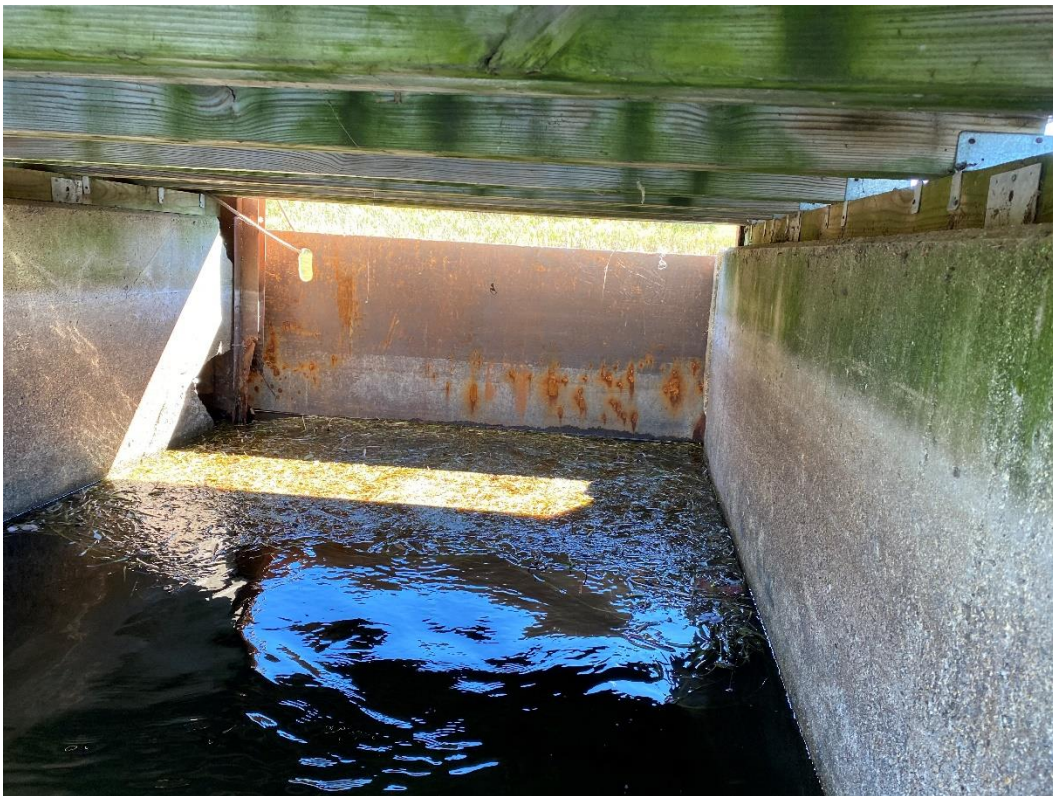
CONCRETE STRUCTURE: Check for erosion; location of cracking or spalling. If old or new; settlement; need for crack repairs. Concrete generally is in very good condition. One pier was damaged at upstream end & is covered with steel face/gate channels and is in very poor condition (see photos).	
WALKWAY & RAILING: Check if in place or removed, condition, and if adequate protection provided. Good condition. Newer fencing.	TRASHRACK OR LOG BOOM: Check if operable. N/A
EMERGENCY SPILLWAY: Size, type, and condition. N/A

Spillway Bay, 4<sup>th</sup> From Left. Note Steel Plate for Lake Control & Bad Pier

1) Replace bad pier, repair damaged pier, and  
 2) Improvements to gate systems

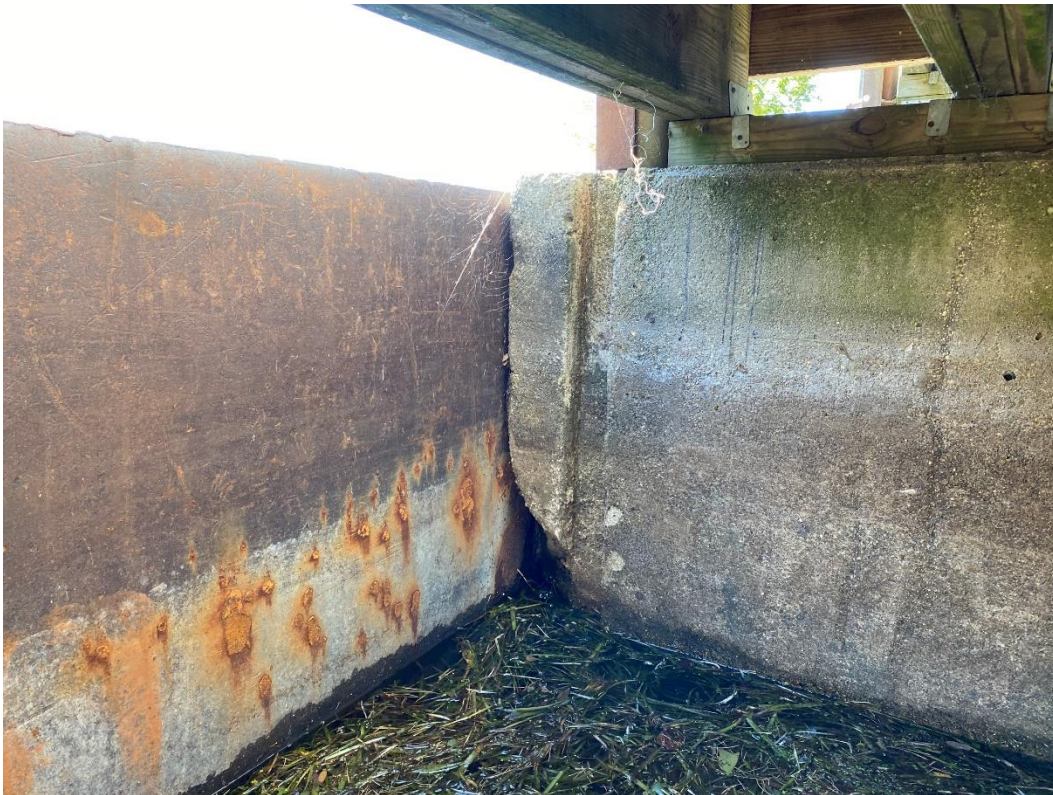
Spillway Bay, 4<sup>th</sup> From Left. Note Damaged Concrete, Left Side of Bay

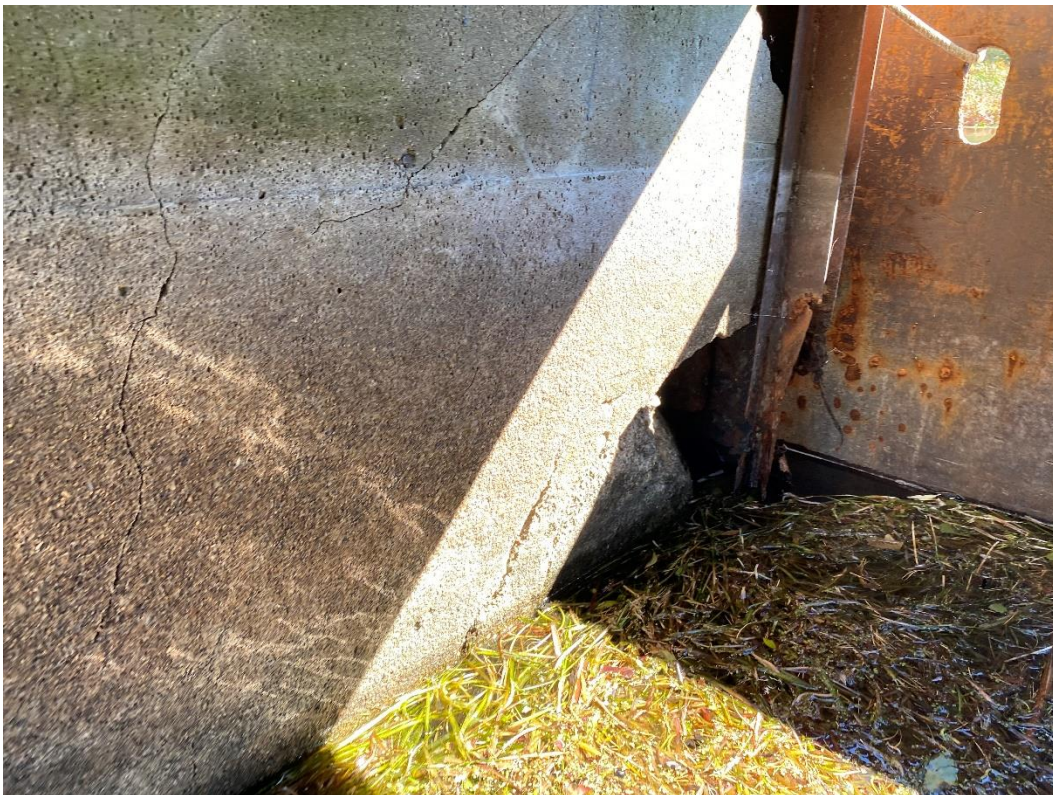
Close Up of Bad Pier, Right Side of Bay

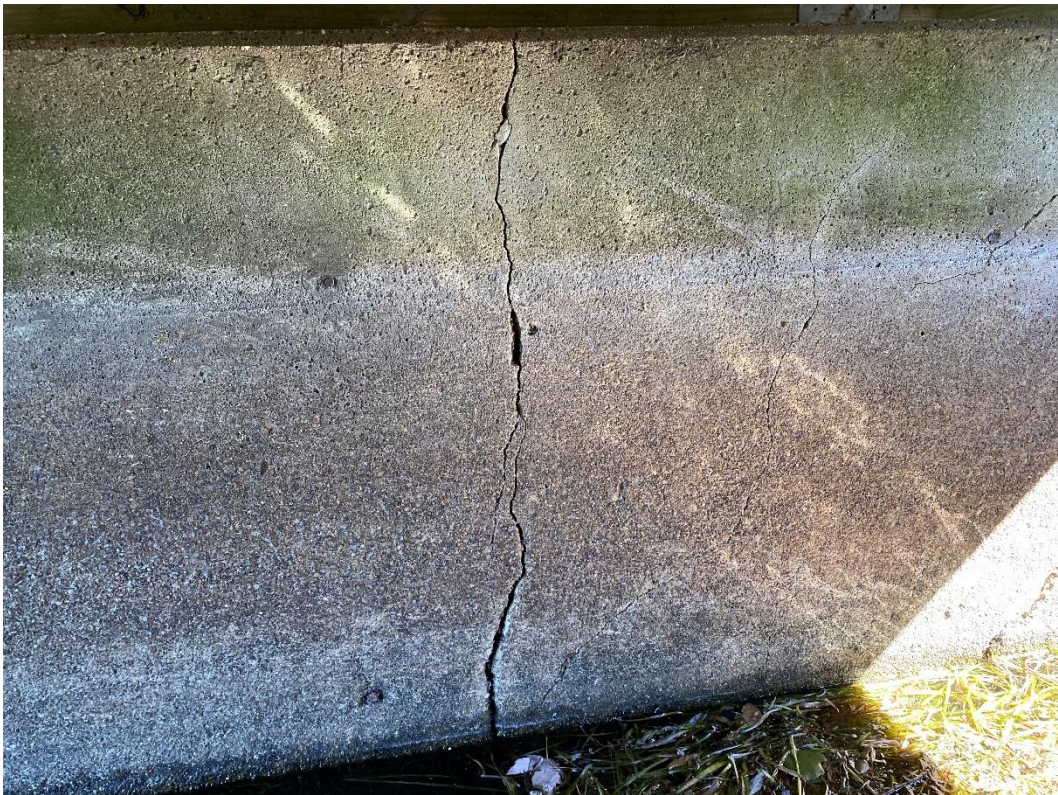
Crack in Same Pier

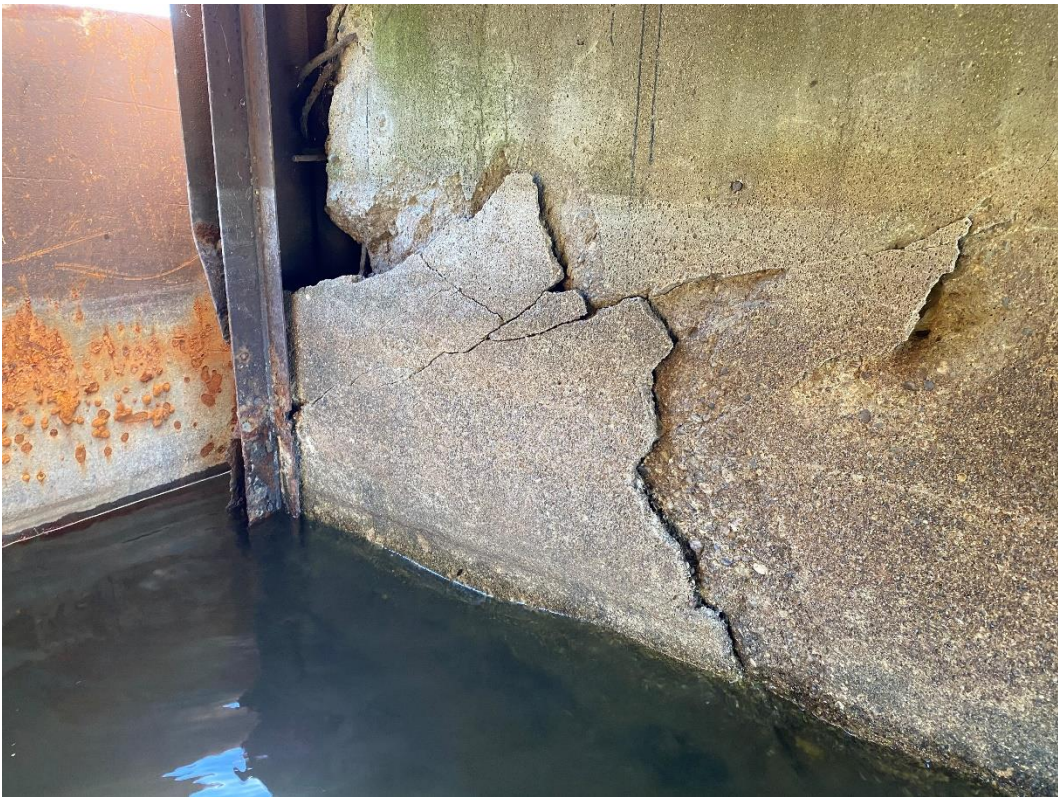
Other Side of Bad Pier

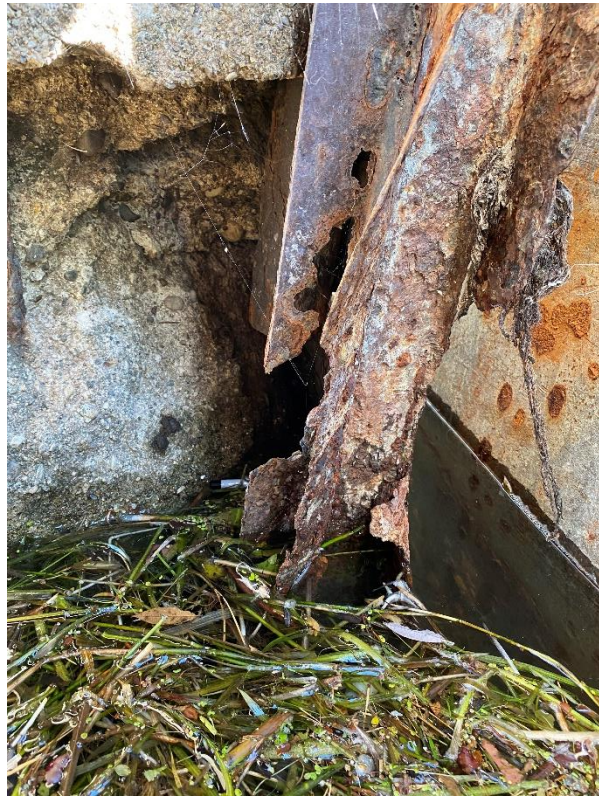
Badly Corroded Gate Channel

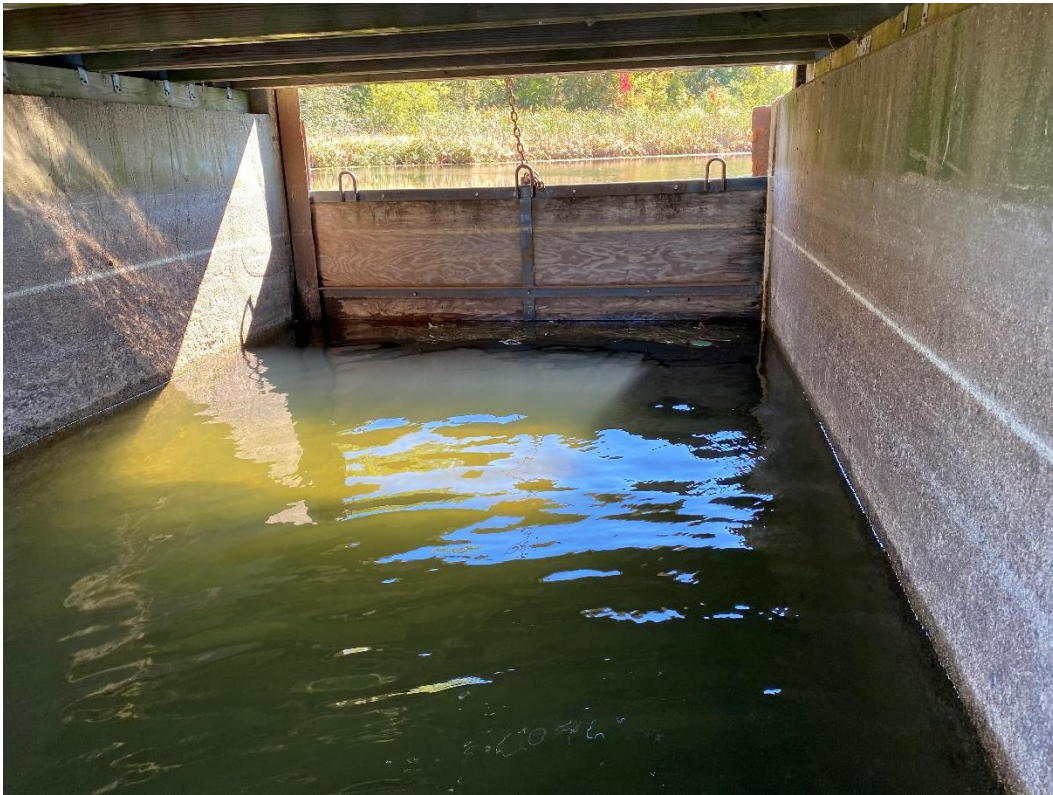
Far Right Spillway Bay

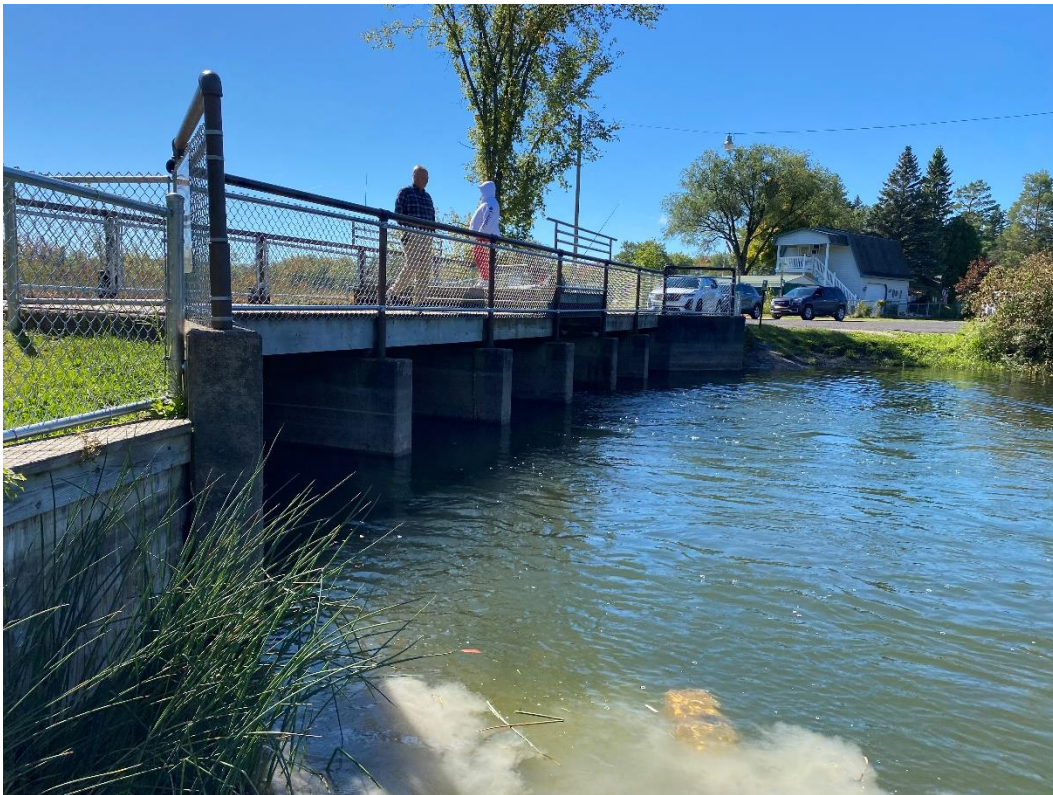
Downstream Side of Dam, From Right

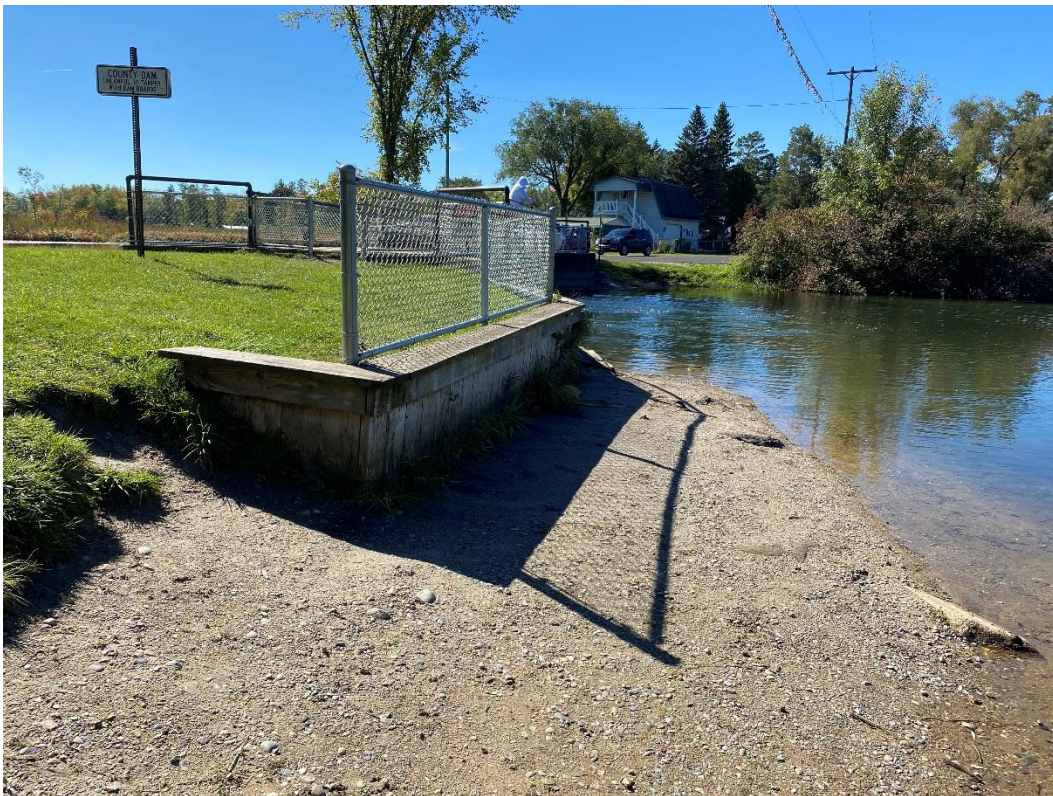
Downstream Right Wingwall

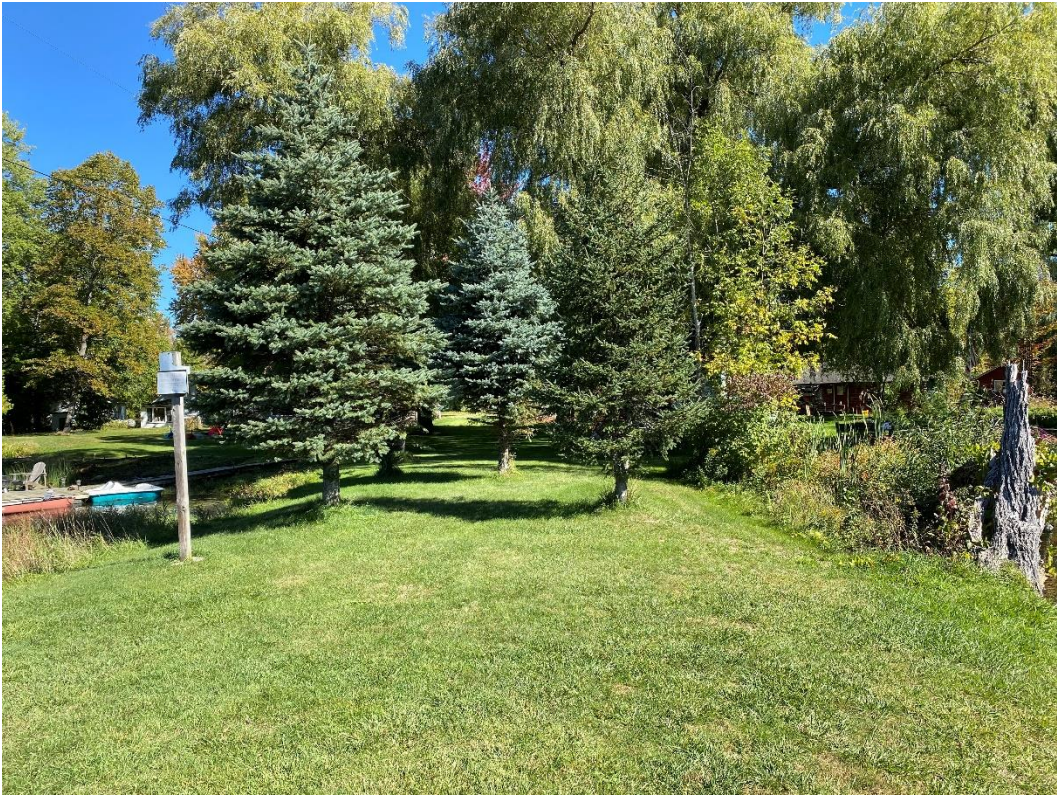
Right Embankment

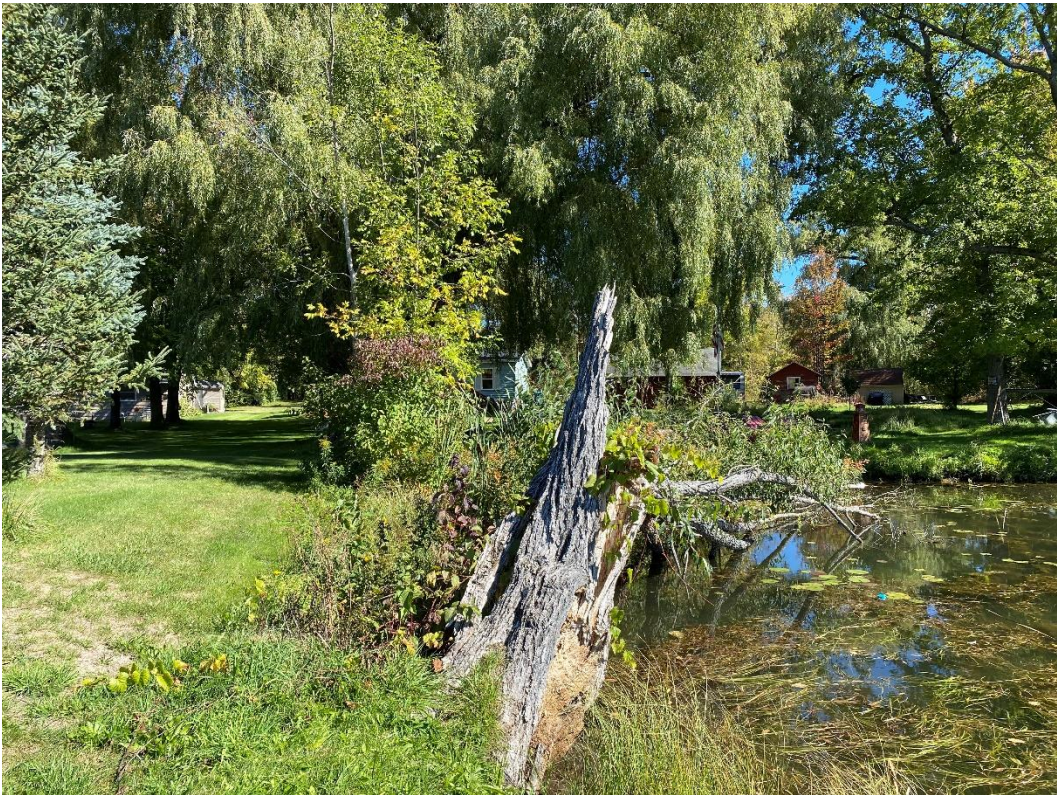
UPSTREAM	CROWN	DOWNSTREAM
VEGETATIVE COVER	Grass/small trees & 1 dead/down large tree, far right	Grass/gravel/4 spruce trees, far right	Grass
EROSION	@L.&R. wingwall-from foot traffic, minor	None	Some from foot traffic-R. & L.
SEEPAGE			None
SLIDES, SLUMPS & CRACKS	None	None	None
ANIMAL BURROWS	None observed	None observed	None observed
WAVE ACTION PROTECTION	Concrete wingwalls. left-timber extension of wingwall		Concrete wingwalls. right-timber extension of wingwall
REMARKS*	/	/	/

Dead/Down Tree on Right Embankment

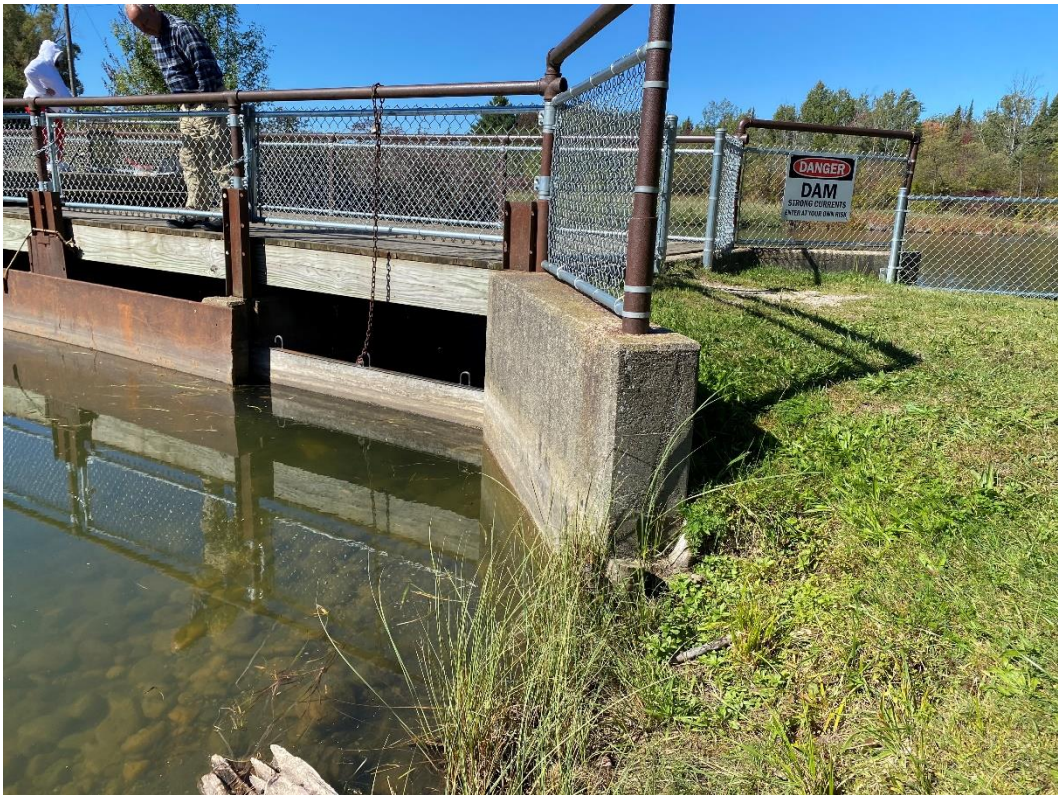
Upstream Right Wingwall

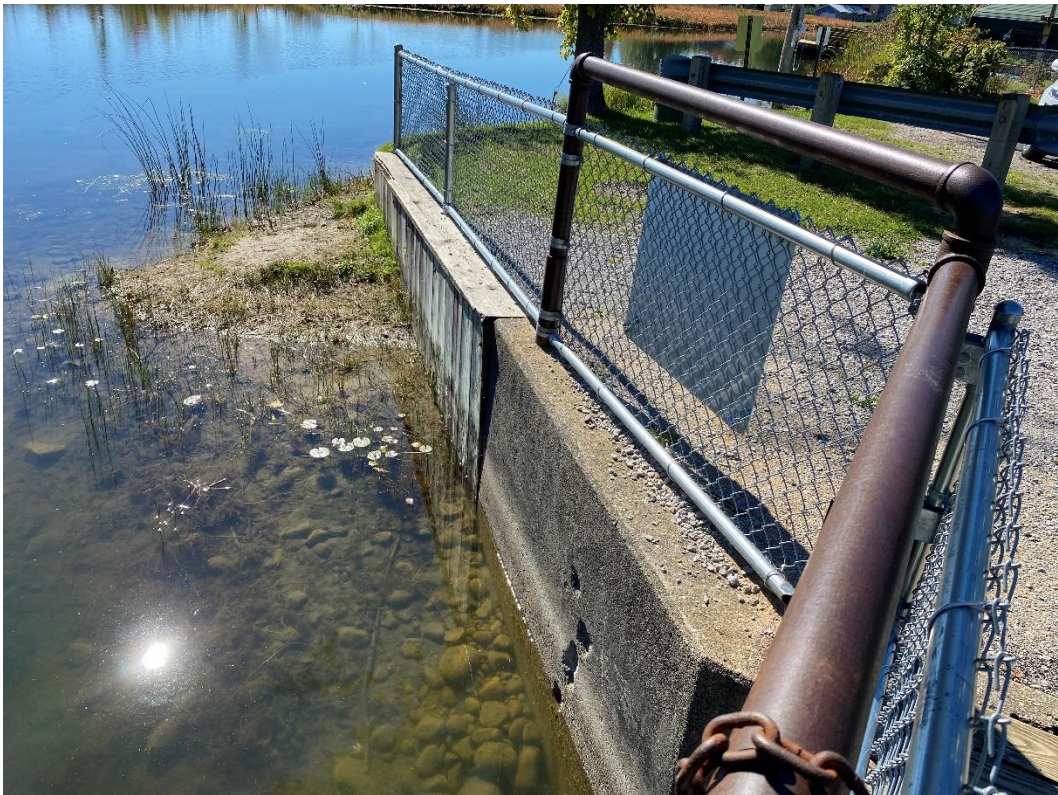
Upstream Left Wingwall

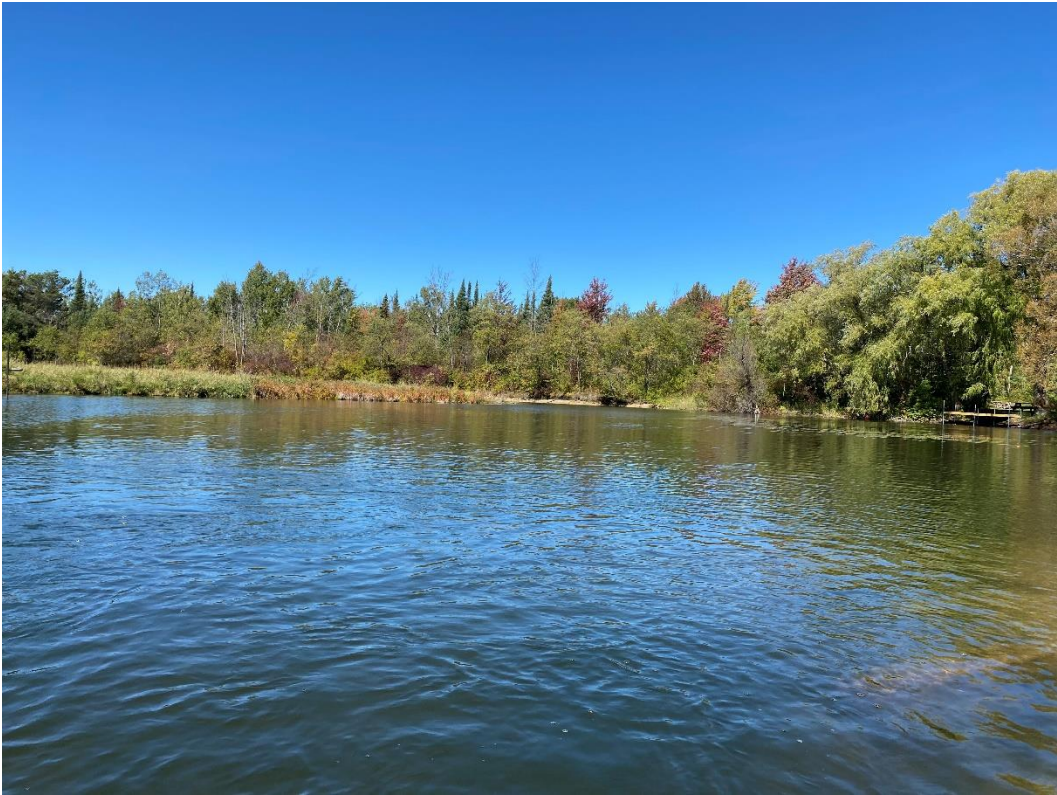
River Downstream of Dam
